# Fire Investigation Summary

# **Dance Hall Fire**

Gothenburg, Sweden October 28, 1998

National Fire Protection Association Fire Investigations Department

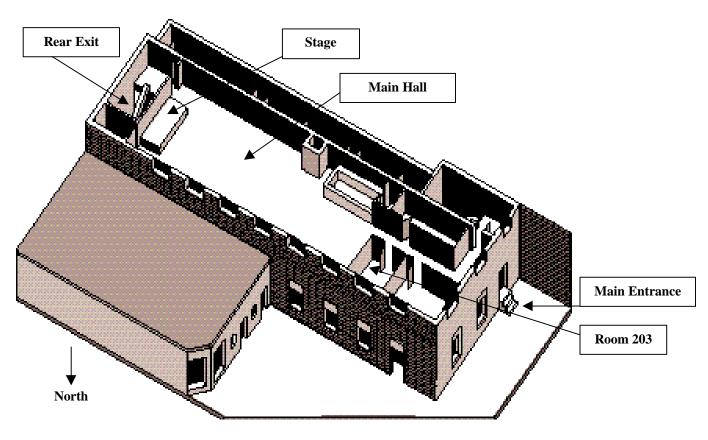
Figure No. 2 - Detailed Site Plan

One room, referred to on the plans as room #203, measured 3.4 m by 4 m (11 ft by 13 ft). Another room, referred to as room #202, measured 5.2 m by 4 m (17 ft by 13 ft). Both of these rooms were equipped with hollow-core doors that swung into the rooms. Room #203 had one exterior window on the northeast wall, and room #202 had two exterior walls, one on the northeast wall and one on the northwest wall. (See Figure 2)

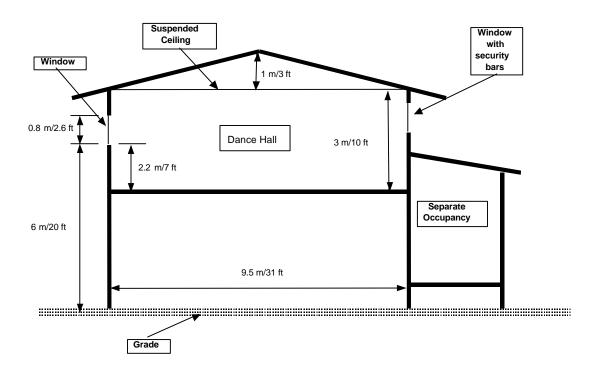
Cross Section A-A (see Figure 5)

The interior walls for these rooms were comprised of wood studs covered with gypsum board on each side. The walls extended upward for a height of approximately 3 m. The remainder of the wall, from the top of the wood stud/gypsum wallboard assembly to the underside of the suspended ceiling was comprised of glass panels. (See Figure 3)

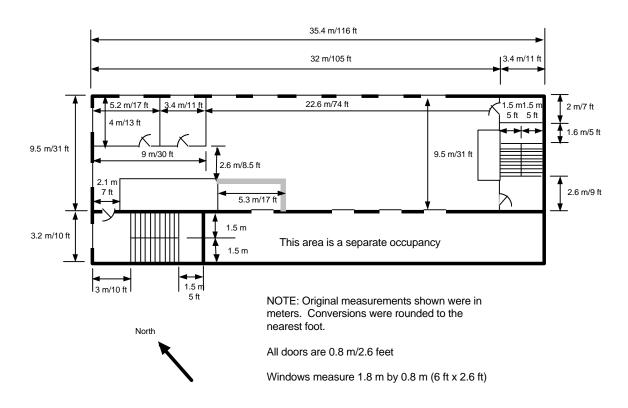
Figure No. 4 – Floor Plan of Building

The total net area of the second floor that made up the main assembly area, when deducting the ancillary rooms, closets, kitchen and serving area was 237 m<sup>2</sup> (2,551 ft<sup>2</sup>). (See Figure 4)

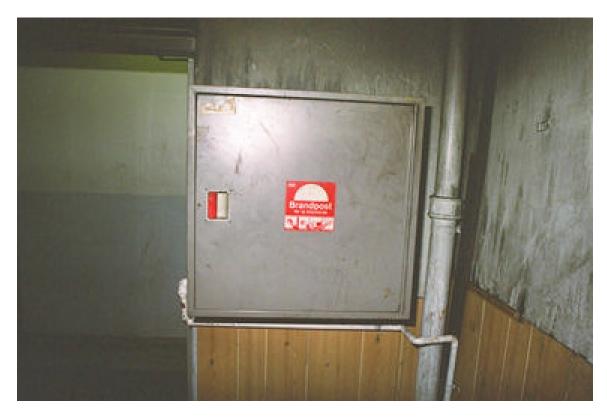
The building was not equipped with an automatic fire alarm or fire sprinkler system. There was an occupant-use hose cabinet in the northwest (main) entrance on the second floor of the building. (It is unknown if this was a wet or dry system.) (See Photo 1)

Photo No. 1 – An occupant-use hose cabinet was located in the entrance corridor adjacent to the exit stairway. (NFPA)

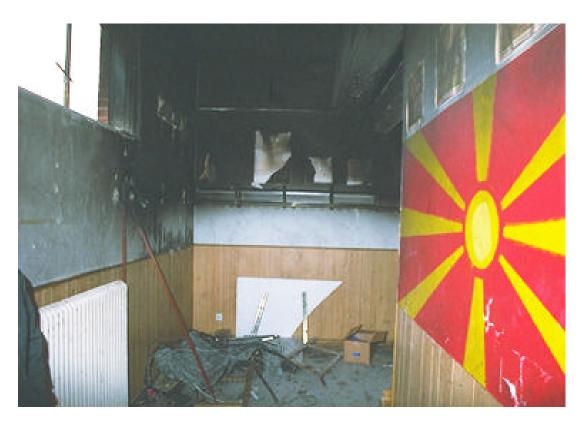
There were two means of egress located at opposite ends of the hall. The door on the northwest end had a 0.8 m (31.2 in.) wide, non-combustible, rated door that swung in the direction of egress travel. This door was equipped with an automatic closer. It led directly to a stairwell that measured 1.5 m (58.8 in.) wide. The treads measured 200 mm (7.9 in.) and the riser measured 200 mm (7.9 in.). This stairway led directly to the exterior of the building. To reach this door, the occupants from the main hall would have to pass through a 2.6 m (8.5 ft) wide, 9 m (30 ft) long corridor, turn left 90 degrees and pass through a 2.1 m (6.9 ft) wide, 2.4 m (7.9 ft) long corridor. (See Photo 2 and Photo 3)

Photo No. 2 – View from the main entrance, leading into the hall. To enter the hall, the occupants would turn right, just beyond the flag on the wall. (NFPA)

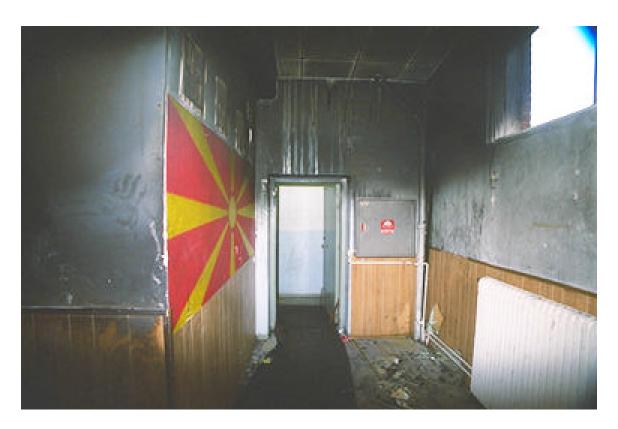
Photo No. 3 - The view towards the main entrance/exit. The dance hall is to the photographer's left in this view. (NFPA)

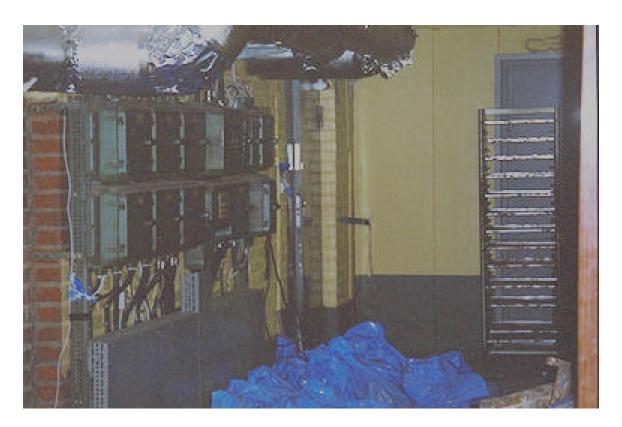
The other means of egress was located in the southeast end of the hall. This entrance was also equipped with a 0.8 m (31.5 in.) wide door that swung in the direction of egress travel. This door was constructed of combustible material, but had a 30-minute fire protection rating and was equipped with an automatic door closer. This door led to a 1.5 m (59 in.) wide stairway that led downstairs to the first floor. The remains of furniture were found in this stairway. One of the survivors reported to investigators that some of the furniture in the hall had been placed in the stairway to make more room. (See Photo 4)

Photo No. 4 – The door at the bottom of the southeast exit from the hall discharged into a common corridor area. (NFPA)

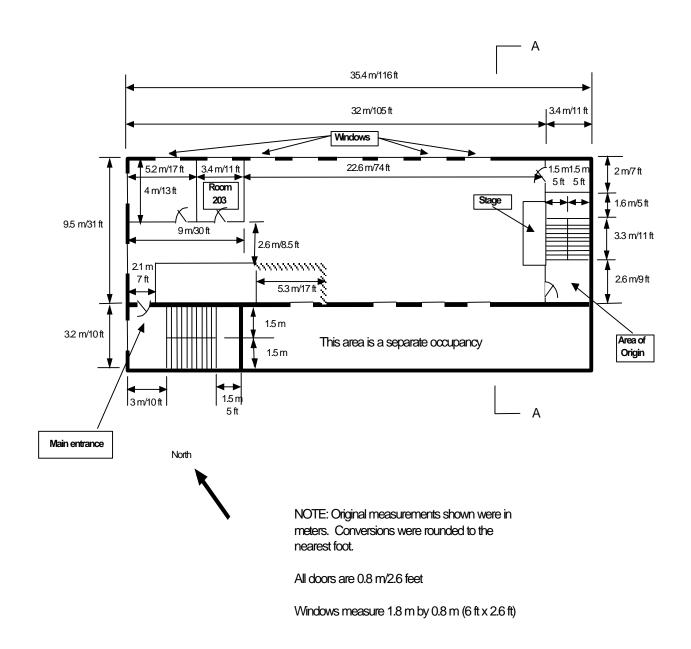
Figure No. 5 - Detailed Floor Plan

Once they were on the first floor, occupants would have then been required to traverse a path that measured approximately 100 m (328 ft) before reaching a door that discharged to the exterior. According to personnel from the fire brigade, this corridor had a one-hour fire rating. This corridor eventually widened sufficiently so that vehicles could enter it to make deliveries and pickups. (See Photo 5 and Figure 5)

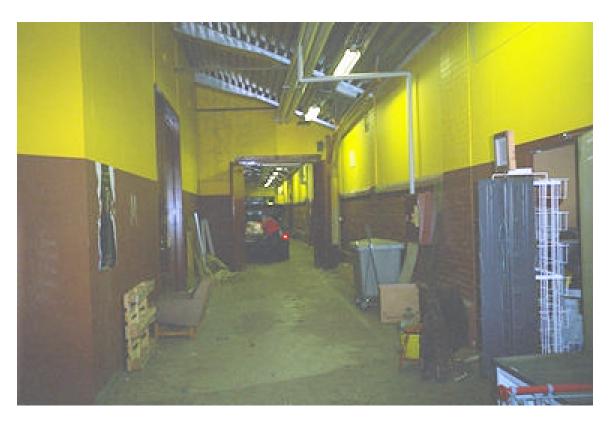
Photo No. 5 – Occupants would have to traverse this corridor to ultimately reach an exit. (NFPA)

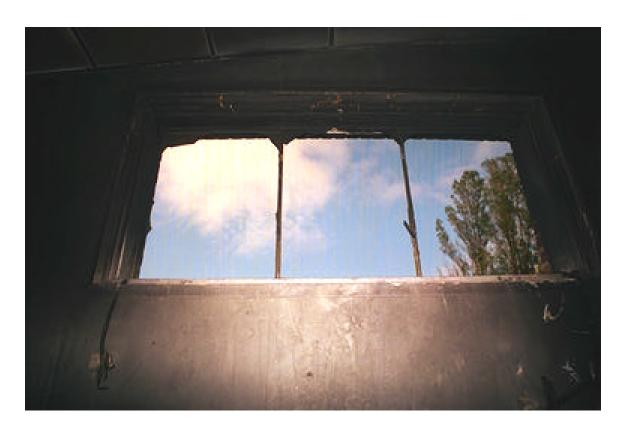
Because of the congestion being caused by the number of people attempting to flee the fire through this one door, others broke out the windows on the northeast wall and jumped to the ground from a height of 6 m (20 ft). These windows were 2.2 m (7.2 ft) above the floor, so it must have been difficult for the occupants to use these windows as a means of escape from the building. (See Photo 6 and Photo 7)

Photo No. 6 – Interior view of window that occupants broke out and jumped from on second level of building. (NFPA)

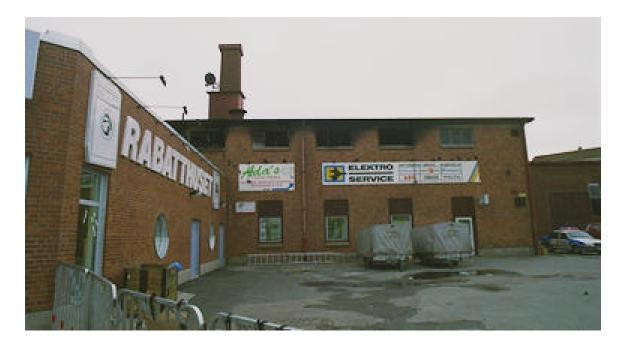
Photo No. 7 – Exterior view of building showing the windows that had been broken out on he second floor and where occupants jumped to the ground. (NFPA)

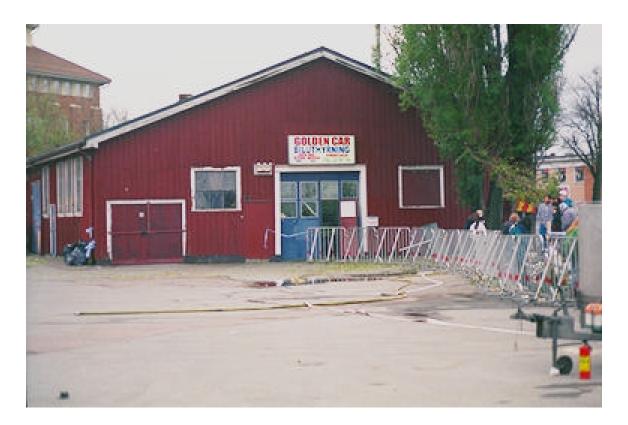
An automotive repair garage adjacent to the building was forced open and used as a triage area for the injured. A liaison with the four local hospitals coordinated the transportation of the injured based on the severity of their injuries. A doctor who was on her way home stopped to assist. (See Photo 8)

Photo No. 8 – This adjacent garage was forced open and used as a triage center for the injured victims. (NFPA)

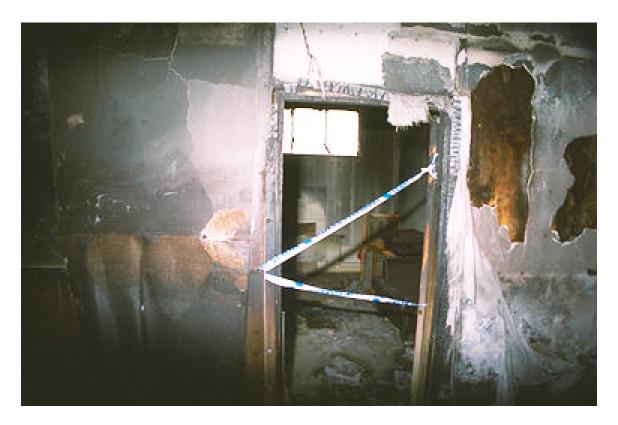
Once the fire was suppressed, 20 additional victims were found in a small room at the northwest end of the hall (room #203). It is theorized that these people were attempting to flee the fire through the main exit when their way was blocked by the

large number of people attempting to pass through the one door. They then attempted to take refuge in the room, but were overcome by smoke. The command officer reported that there were victims piled three to four feet deep in this room. (See Photo 9)

Photo No. 9 – In Room 203 a number of victims had attempted to take refuge from the smoke and flames. (NFPA)

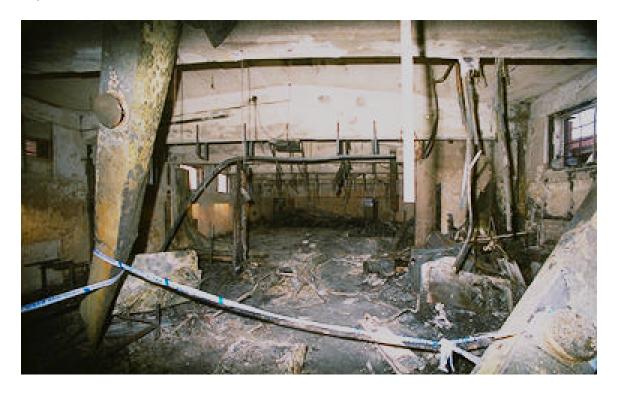
The main hall area was severely damaged by the fire. The ceiling assembly was also destroyed. Seven of the eight exterior windows on the northeast side were totally destroyed. All five windows on the southwest side were also destroyed. (See Photo 10)

Photo No. 10 – This is a view of the interior of the main hall from the entrance looking towards the stage. (Note: None of the contents had been removed from the area when this photo was taken.)

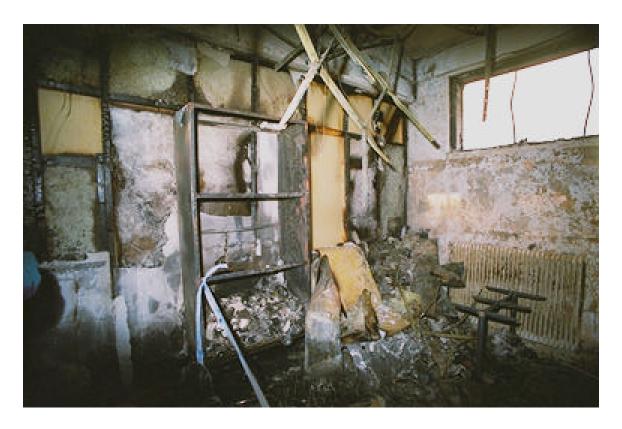
Room #203 on the northwest end of the hall had heavy smoke damage. This is the room where a large number of people attempted to flee the fire and were overcome by smoke. The condition of the door to this room was unknown. However, the glass panels at the top of the wall to this room were totally destroyed by fire. The next room moving further towards the northwest room, room #202, received smoke damage from the fire. Reportedly this door was closed and locked during the incident, so no one was able to gain access to this room. (See Photo 11)

Photo No. 11 – This is the wall that separated Room #203 from the main hall. At the top of the wall were glass panels that failed during the fire, allowing smoke to spread into this room.

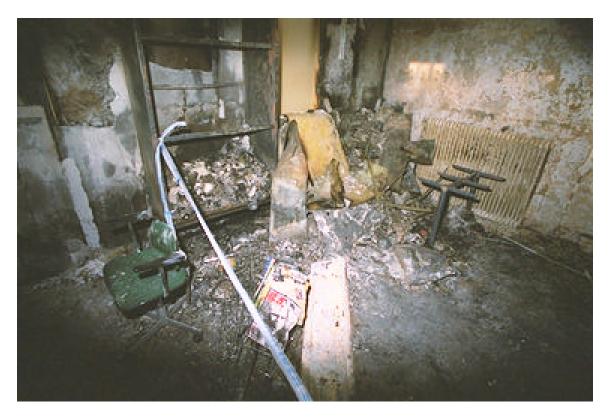
The fire was fueled by the presence of combustible furniture stored in the stairway. Once the fire spread into the hall from the stairway, it ignited the combustible furnishings and decorations. It then spread to the northwest throughout the hall. There were reports of combustible decorations hanging from the ceiling and on the walls that would have also fueled the fire. The type and quantity of these decorations is unknown. The interior finish in the hall was possibly comprised of combustible wood paneling, which provided an additional fuel load. (See Photo 12)

Photo No. 12 – The furnishings in the Main hall comprised mainly of combustible materials over metal frames.
